**MALFUNCTION OF IGNITERS IN
THE AMRA VARIABLE PARAMETER
ROCKET ENGINE**

TECHNICAL NOTE

JULY 1965

**MATERIALS ENGINEERING DIVISION
U. S. ARMY MATERIALS RESEARCH AGENCY
WATERTOWN, MASSACHUSETTS 02172**

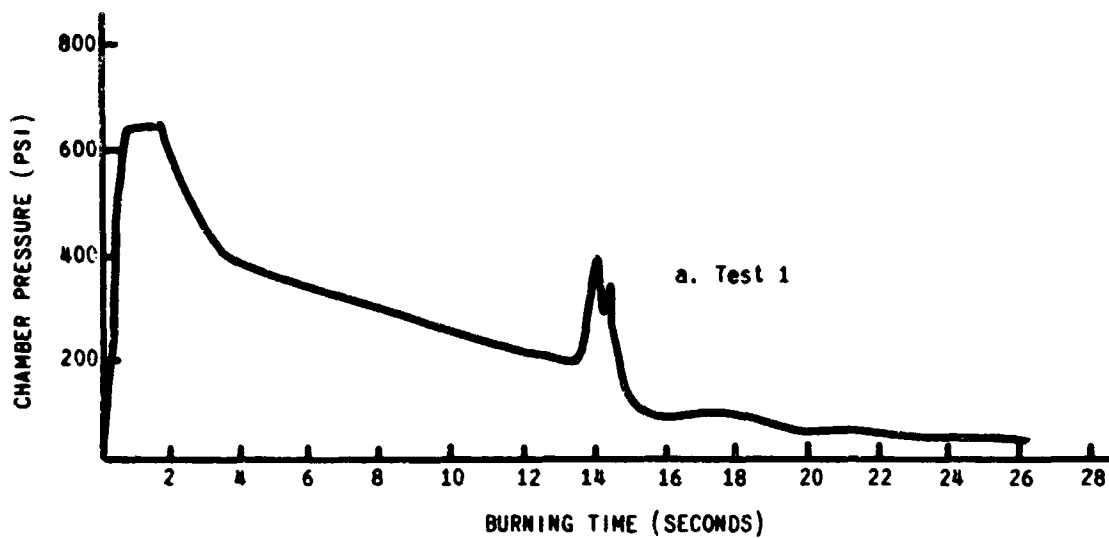
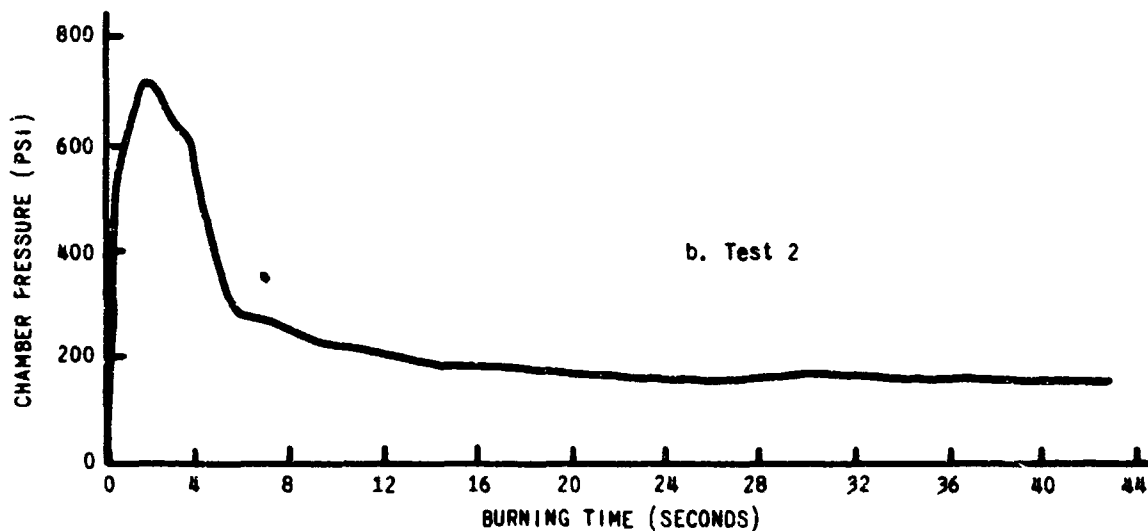
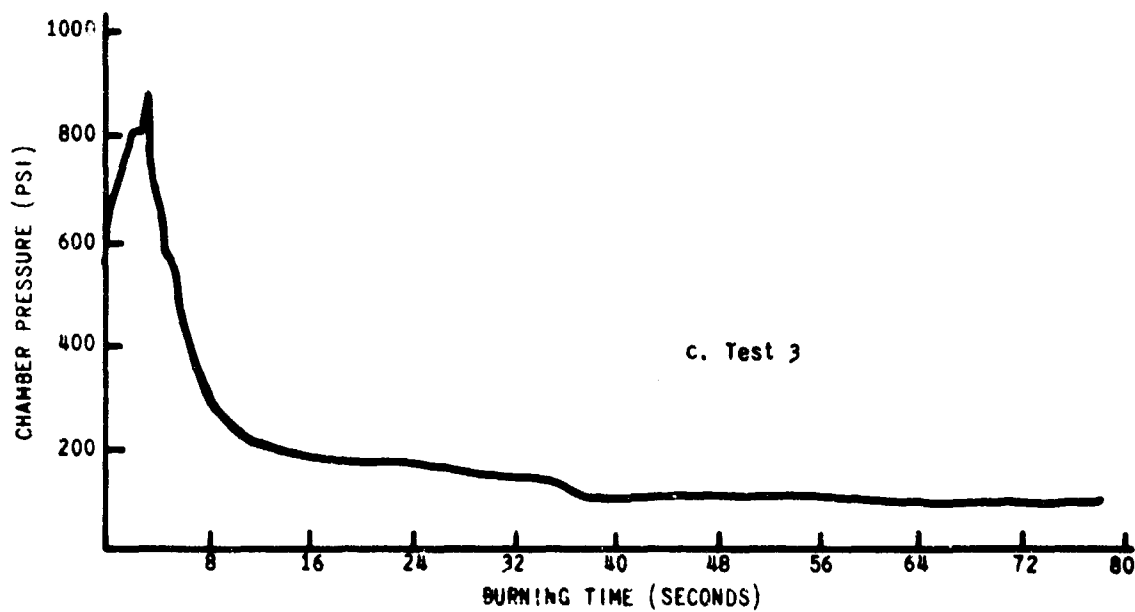
Figure 5. PRESSURE TRACINGS

final inspection of the engine assembly for the first test, the electrical firing leads were attached to both igniters and the firing commenced in a normal manner. Subsequent examination of the pressure transient data indicated that the pressure following ignition rose to a maximum of approximately 630 psi in 1/2 second, leveled off on a plateau for 1-1/2 seconds, and began to decrease at the rate of about 35 psi per second. A copy of the pressure burning time trace is shown in Figure 5a. Here it may be observed that a pressure plate pulse occurred at the 14-second mark, which is attributable to the delayed activation of the second igniter. The rapid decrease in pressure after the 2-second mark is directly attributable to expulsion of the ceramic pressure seal and erosion of the igniter since this engine is of the constant burning surface area type and since examination revealed less than 1 percent increase in the throat diameter of the nozzle. The total burning time of the test was extended to approximately 28 seconds.

Despite the care taken in the latter two tests, the same phenomena occurred. Figures 5b and 5c are copies of the pressure-burning time curves of tests No. 2 and 3 showing actual chamber pressure build-up after ignition to maximums of 710 and 870 psi, respectively, in less than one second. Pressure instability due to failure at the igniter seal was evident from a sharp decrease in chamber pressure. Subsequent post-firing examinations of the test nozzles revealed negligible throat erosion, indicating progressive failure of the igniter as the primary cause of pressure instability and regression.

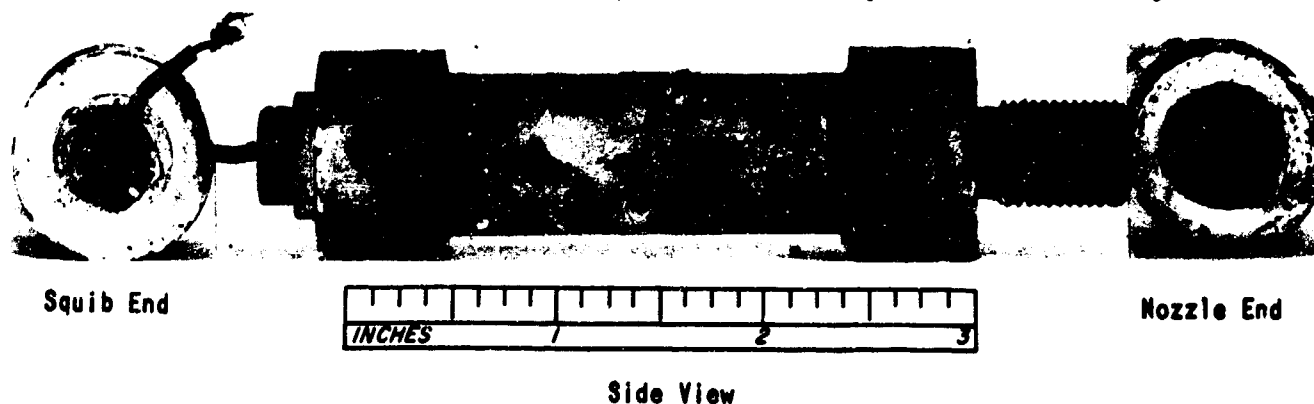
body can be removed intact from the engine. A satisfactory used igniter unit is shown in Figure 8. This igniter was one of the two utilized in test No. 1 and was easily removed from the side closure plate. Although the paint on the body was scorched, the steel body retained its physical

Figure 8. VPRE TEST 1, EXHAUSTED IGNITER

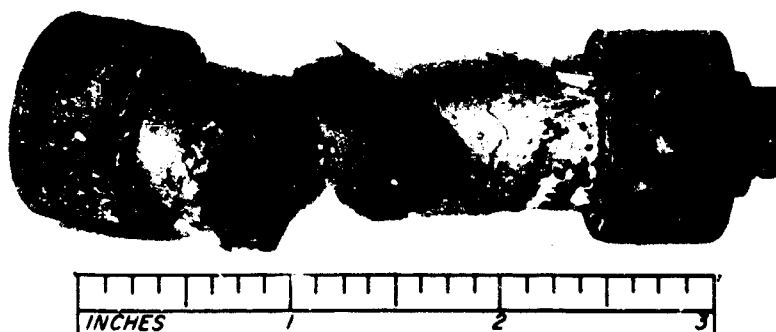
integrity. In contrast, the igniter body salvaged from the protective earth bank after the first test was blackened and scaled from overheating, its threaded nozzle section completely disintegrated, and its center body section almost eroded in half as shown in Figure 9. The igniters recovered from subsequent tests were similar in appearance except that the

Figure 9. VPRE TEST 1, ERODED IGNITER

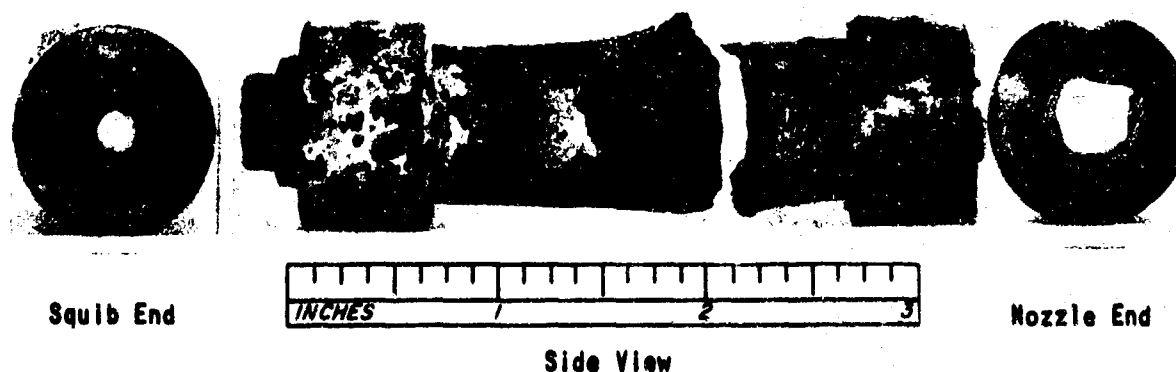
erosion progressed completely through the wall separating the squib end from the nozzle end. Figure 10 shows three views of the salvaged igniter fragments from test No. 2. Note in the view of the squib end that the ceramic seal and lead wires have been removed in entirety and the remaining orifice only slightly enlarged, while the nozzle end has become completely disintegrated. A comparison may be made of this figure with that of Figure 8 which shows the integral though exhausted pyrotechnic unit of the first test. It was speculated that in each test the igniter wires were forced out of the seal by the high pressure gases followed by the ceramic sealant itself. As the hot gases flowed out at high velocity through the squib end orifice, the center body section and the nozzle end overheated causing erosion of the center wall. This allowed an increase in the flow of gases, inducing complete erosion of the threaded nozzle section, as shown in Figure 10, and consequent ejection of the igniter body. As mentioned previously, the malfunction of the igniter contributed directly to the regression of chamber pressure and loss of test data.

Figure 10. VPRE TEST 2. ERODED IGNITER

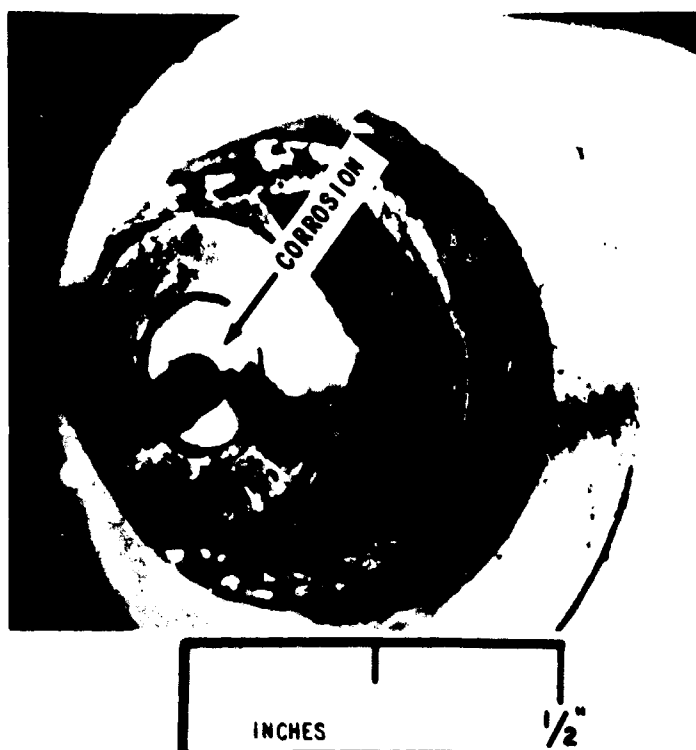
Further examination, including visual inspection with a binocular microscope, disclosed a rust-colored layer on the surface of several igniter wires in the area immediately adjacent to the entrance of the wire into the ceramic seal. A representative photograph of this condition is shown by the enlarged end view of the igniter in Figure 11. The affected area is the thin dark band on the wire just below the polyvinylchloride insulation. The width of a typical band was approximately 1/32 inch and completely encircled the wire. In order to determine the extent and intensity of the attack, several exhausted squibs were sectioned, as shown in Figure 12. The

Figure 11. PROPELLANT IGNITER, SQUIB END
DIAGONAL VIEW

In lieu of further concrete evidence, the manufacturer's representative, while acknowledging no responsibility for the malfunction of the igniters, proposed to remedy the problem in the interest of improving functional reliability of the component, by replacing the primer squib element and protecting the lead wire at the junction of the pressure seal with a dab of asphalt cement. The proposal was accepted and the igniters on hand (approximately 60) were reconditioned at no cost to the government.

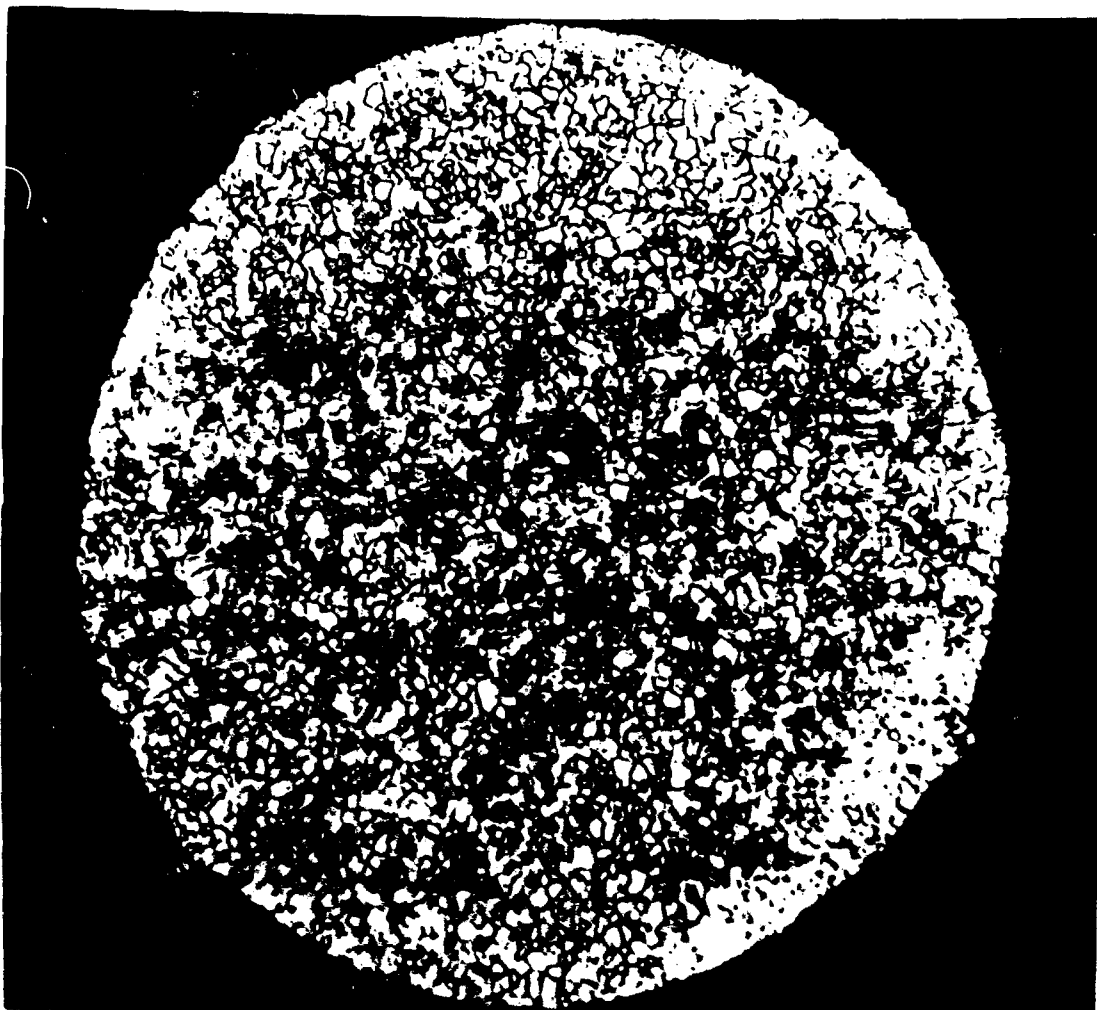
wire embedded in the fused ceramic sealant was clean and shiny except in the regions of corrosion. Inspection revealed that the rust penetrated below the exterior surface of the sealant to a depth of about 1/32 inch as illustrated by the photograph. The igniter wire was removed for further study. Metallographic examination of the diametral cross section revealed a coarse grain structure as shown in Figure 13. Under higher magnification, the presence of a coating approximately 0.0002 inch was revealed. Figure 14 is a representative photomicrograph of the coated surfaces. X-ray diffraction analysis indicated the wire composition to be mainly iron possibly flash plated with an intermediate layer of copper, followed by a thin layer of tin. Inspection of the wire approaching the wire-sealant

Figure 13. IGNITER WIRE - CROSS-SECTION. Mag. 150X

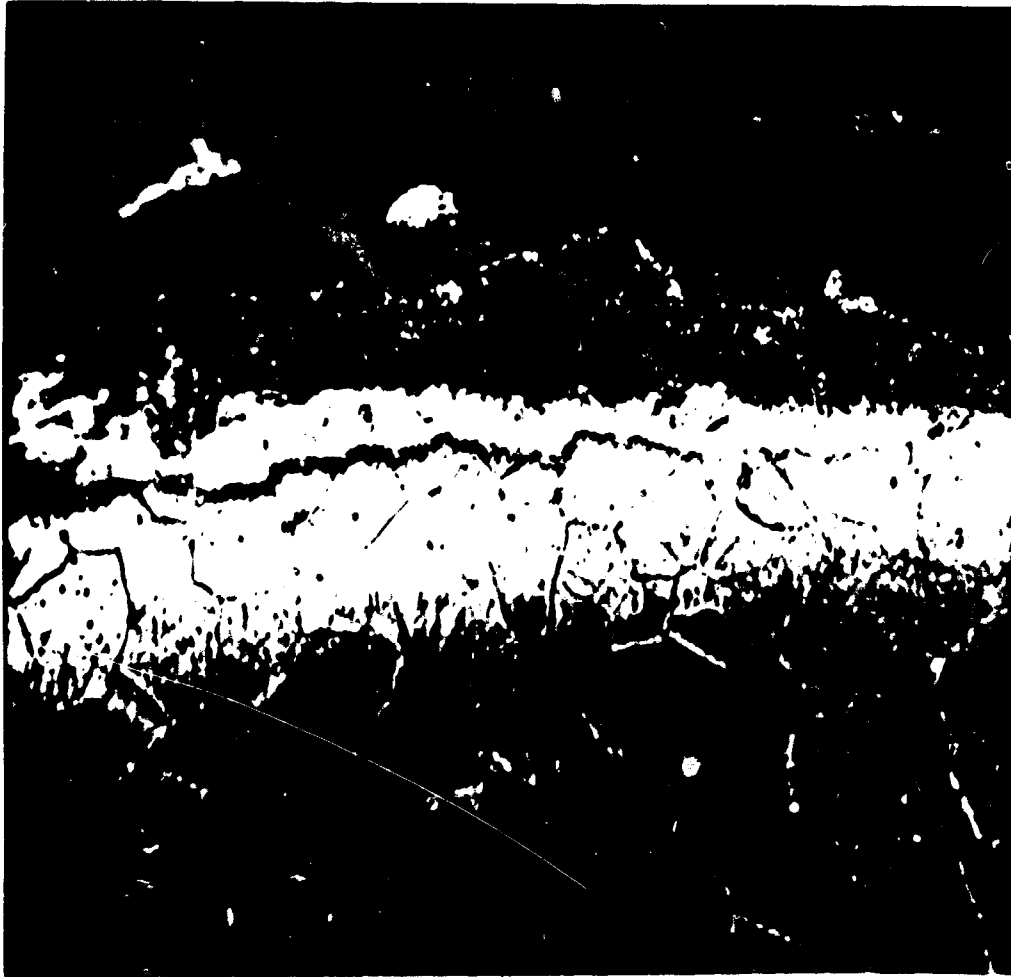
Figure 14. IGNITER WIRE - COPPER TIN COATING ON IRON WIRE. Mag. 1000X

intersection revealed a decreasing amount of coating material. The wire embedded in the sealant itself was not coated. Based on these observations, it is speculated that the assembly of the ignition wire to the squib consists of first fusing the wire into the ceramic sealant and secondly, applying a protective coating. The method utilized does not appear to provide sufficient coating to the full length of bare wire, thereby exposing vital areas to the corrupting environment. Examination of corroded areas disclosed the lack of a protective coating, as shown in Figure 15. However, the areas of greatest concentration of corrosion products on the wire were above the glassy sealant's external surface.

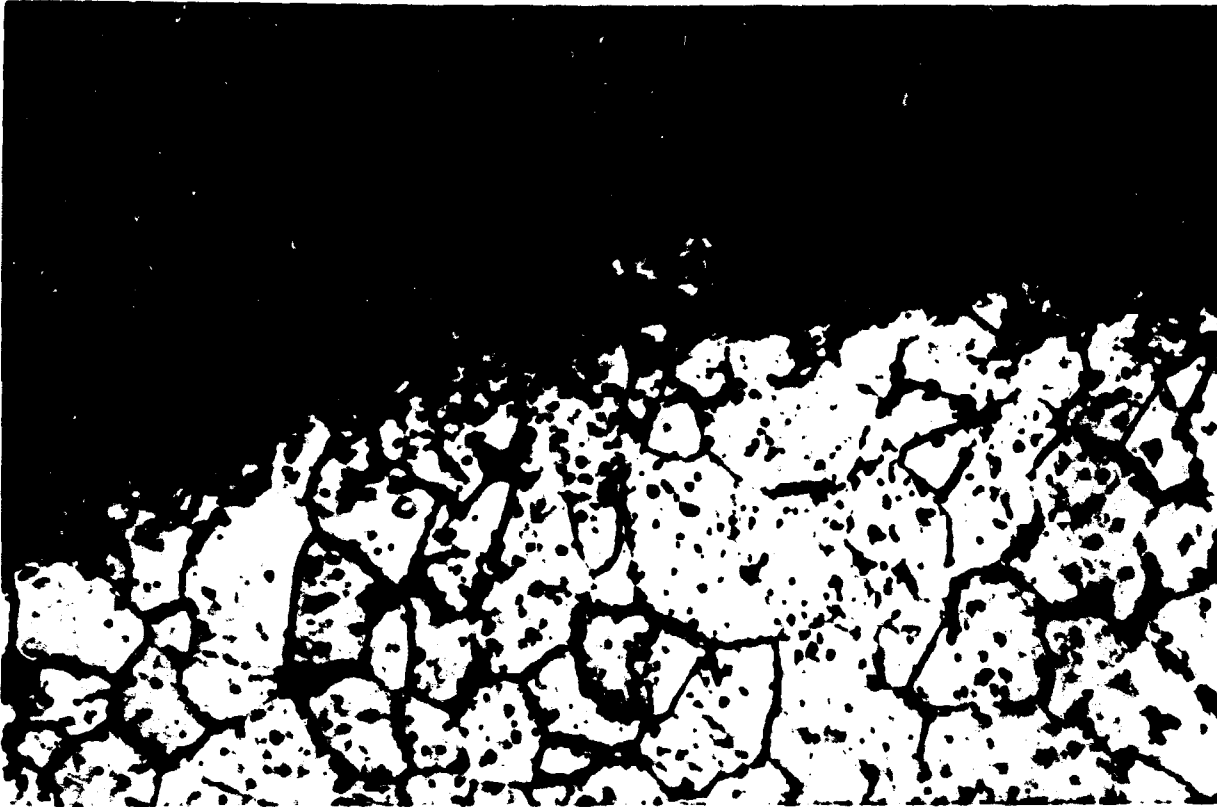
Although the investigation did not conclusively pinpoint the cause of failure, the microscopic and photographic studies did provide sufficient telltale evidence to mark the squib primer element as the suspect part. It was speculated that corrosion of the ignition lead wire, promoted by a combination of inadequate protection and corrosive atmosphere, initiated in an exterior area immediately adjacent to the surface of the pressure sealant and progressed into the glassy seal area to such a depth as to reduce the shear resistance between the wire and seal. Upon application

Figure 15. IGNITER WIRE - CORRODED AREA. Mag. 1000X

of pressure and heat, the wire was ejected, leaving a path for the hot gases to flow.
